**PHASE II ENVIRONMENTAL SITE ASSESSMENT  
FOR  
LITTLE GEYSERS CHILD CARE CENTER  
603 YELLOWSTONE AVENUE  
WEST YELLOWSTONE, MONTANA 59758**

Date Prepared	August 2016
TDD No.	0003/1602-07
Document Control No.	W0321.1A.00969
Contract No.	EP-S8-13-01
U.S. EPA Work Assignment Manager	Tim Rehder

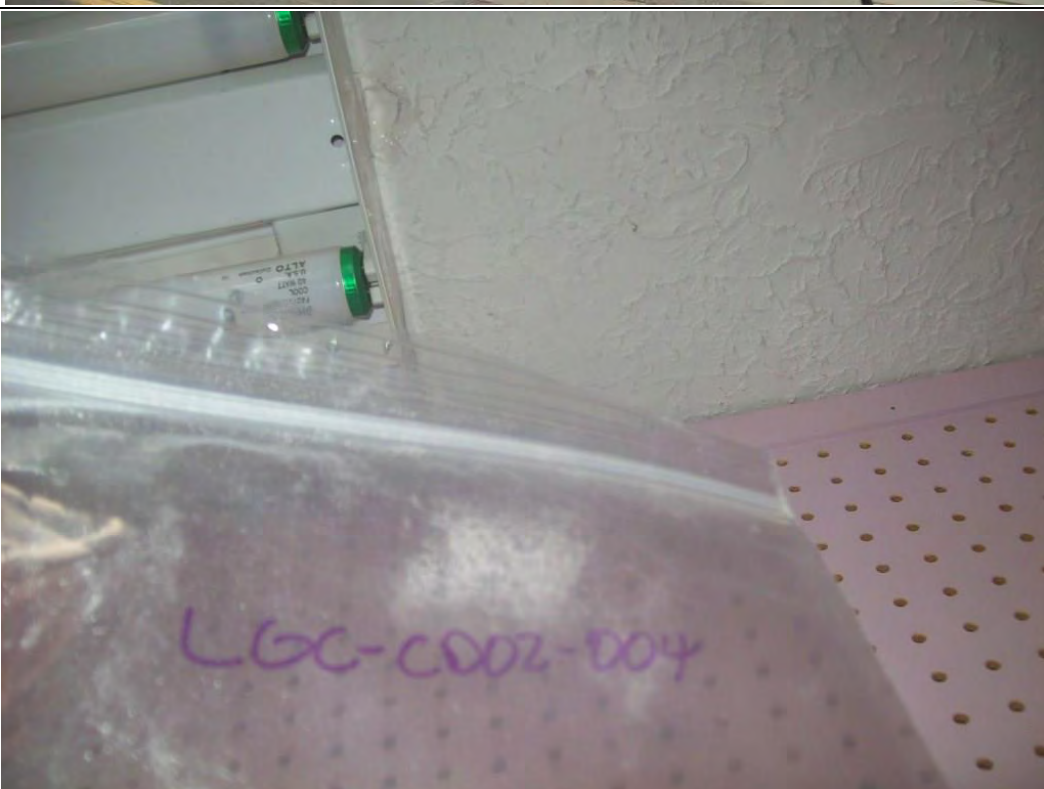
Description:  Confirmed ACM drywall sample LGC-CD02-004 from the laundry area upstairs.

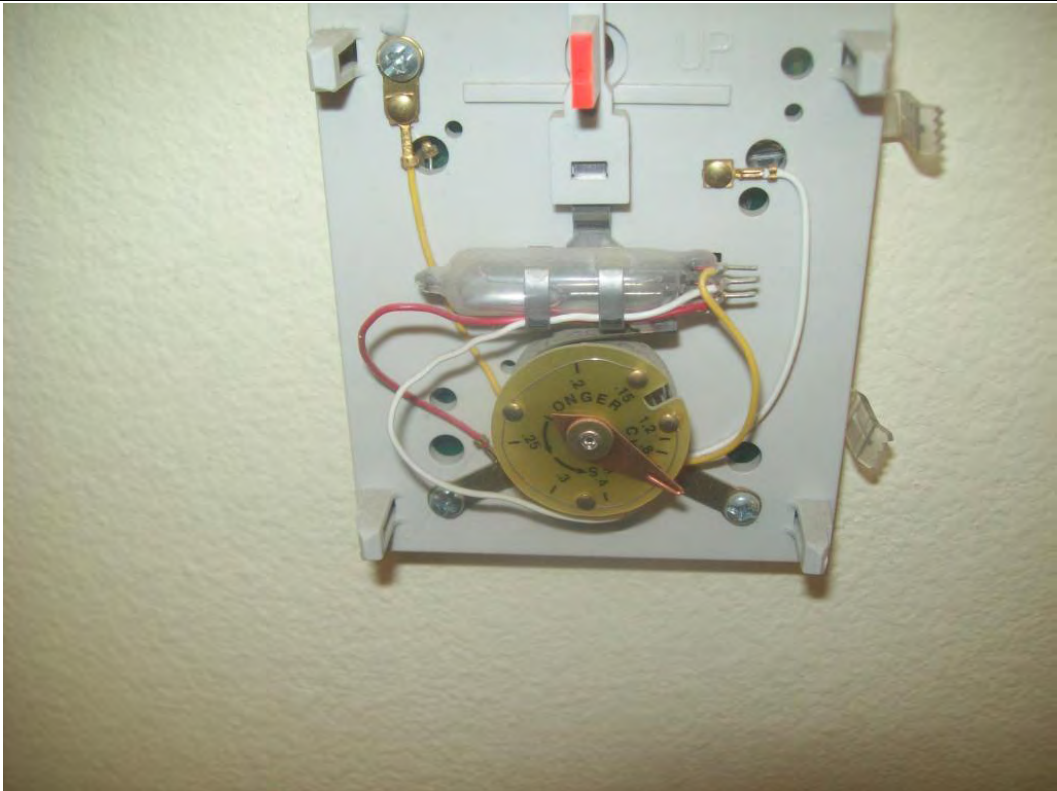
<b>Photo No.</b> 7	<b>Date:</b> 04/16/2016

- Four mercury-containing thermostats were observed. Two mercury thermostats switches were identified on the first floor and two mercury thermostats were identified on the second floor.
- No mold was encountered at the subject property.

<b>Description:</b>  Mercury thermostat present in upstairs area. One of two found.		
<b>Photo No.</b> 8	<b>Date:</b> 04/16/2016

- If PCB-containing equipment (e.g., light ballasts) is encountered during renovation or repair activities, it should be properly removed and disposed.
- The mercury-containing thermostat switches should be removed and properly disposed.

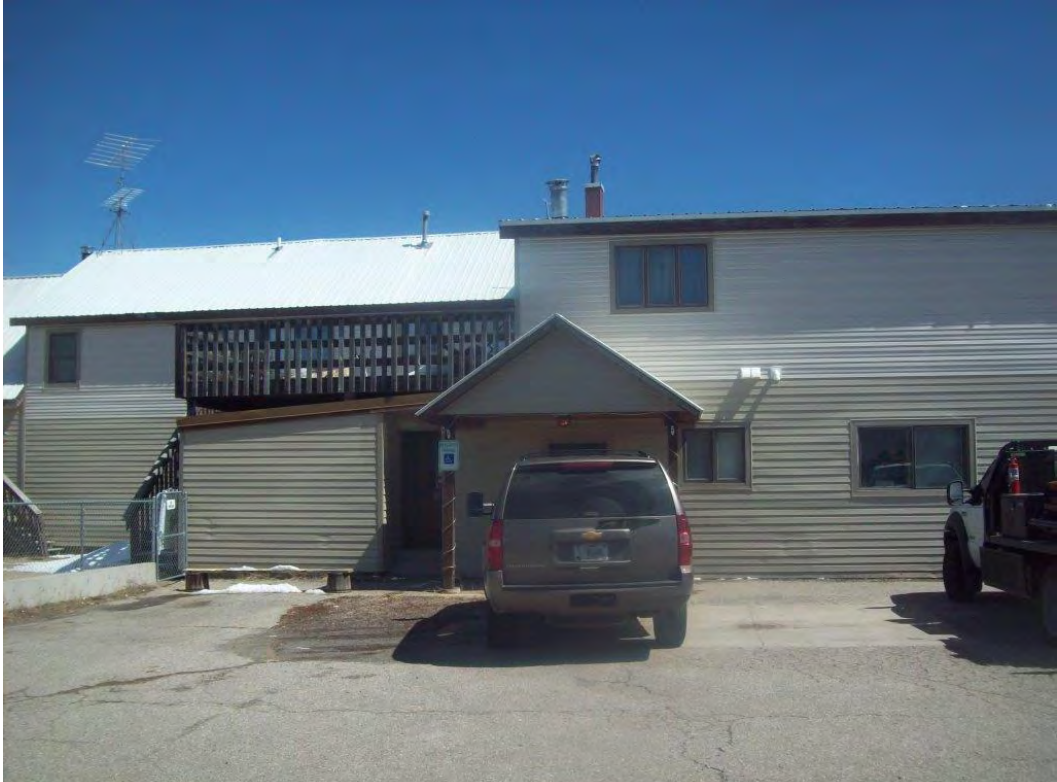
<b>Description:</b>  Westside of the exterior. Deck and adjacent area is an addition.

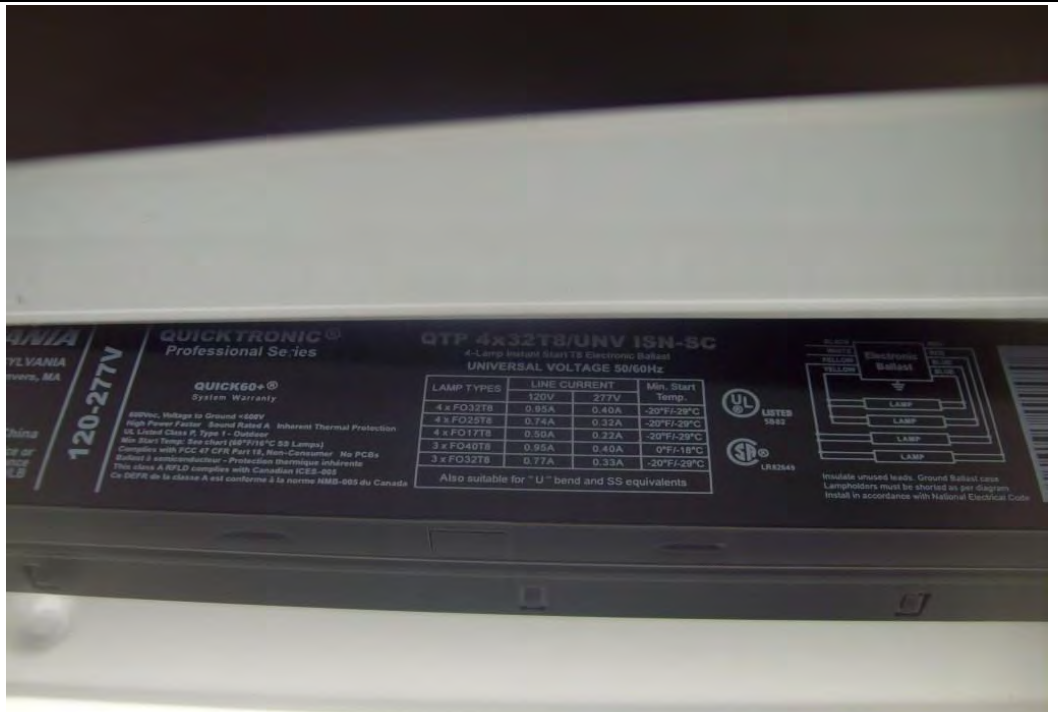
<div>Photo No. 12</div>	<div>Date: 04/16/2016</div>	<div>Description:</div> <div>Verification of a "No PCBs" ballast present</div>

- Light fixtures in the building primarily used fluorescent bulbs. A total of 56 ballasts were counted during the inspection. None of the light fixtures observed in the building appeared to be leaking fluids. Presence of non-PCB ballasts was confirmed during the inspection. Because it was not practical to check every ballast, the potential for presence of PCB ballasts still remains; however, due to the similarity of ballasts checked and like-ballasts not checked, the likelihood of PCBs present is considered low.

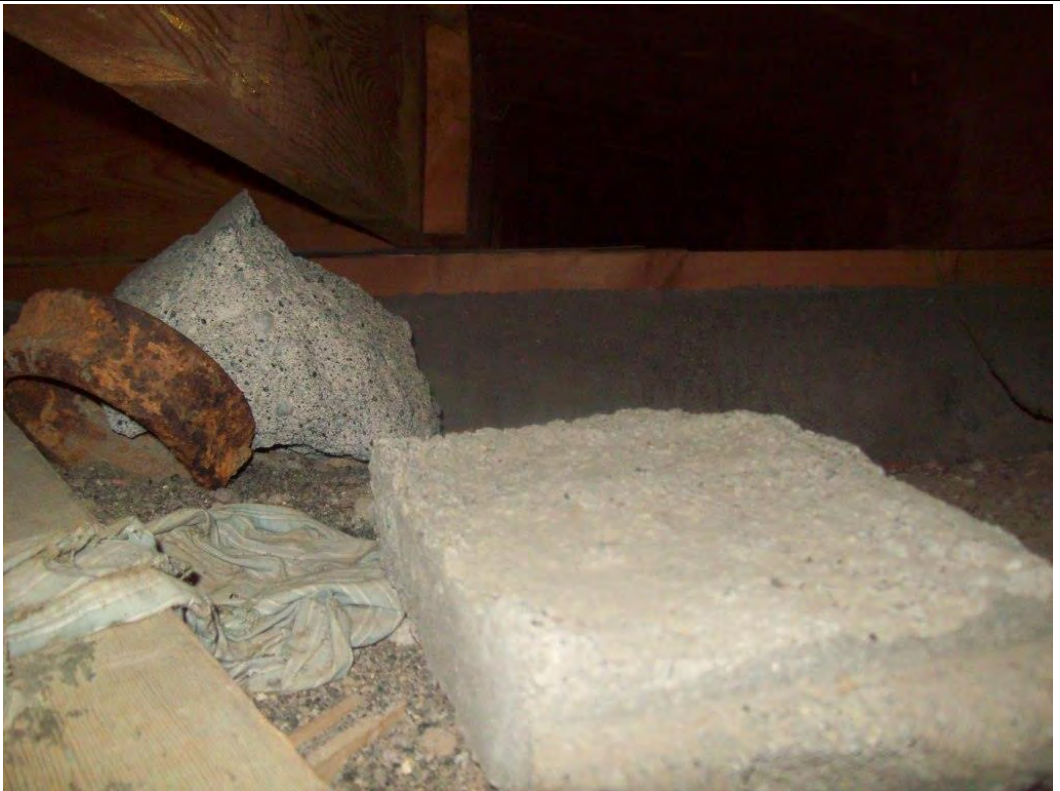
<b>Photo No.</b> <b>13</b>	<b>Date:</b> 04/16/2016

<b>Description:</b>  Shot of the crawlspace. No suspect materials present.		
<b>Photo No.</b> <b>14</b>	<b>Date:</b> 04/16/2016

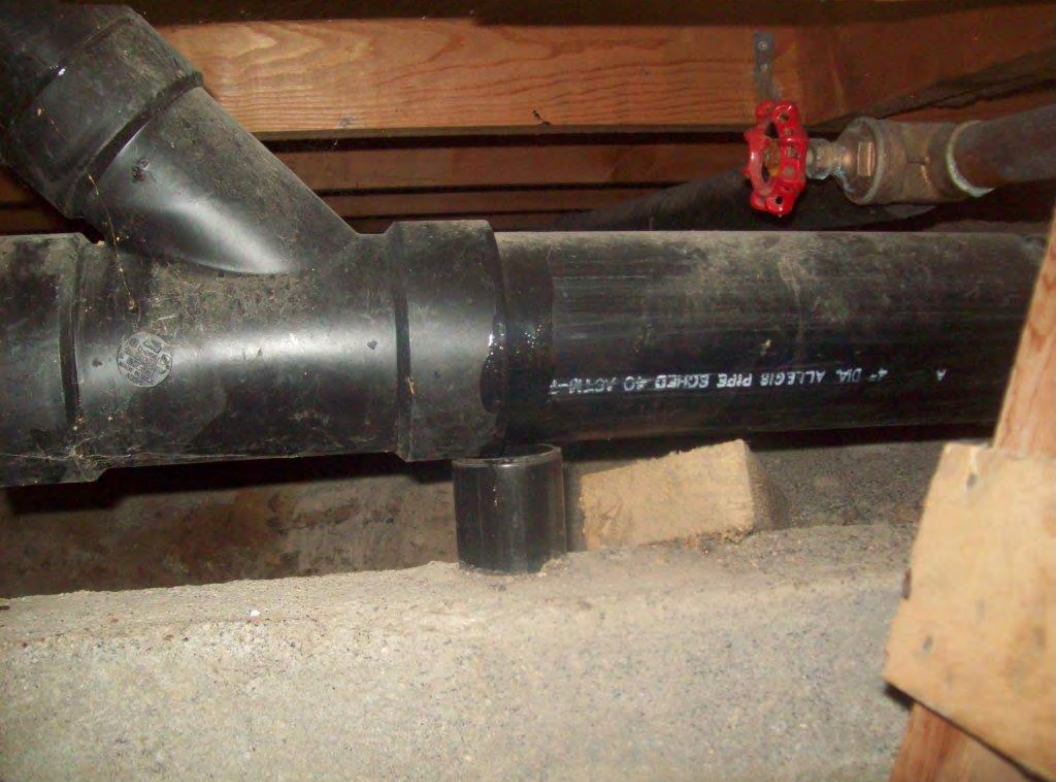
<b>Description:</b>  Shot of the crawlspace. No insulations or suspect materials present.
